CAFO FACILITY INSPECTION REPORT

<u>8365995001</u> WDID NUMBER	<u>James Jongsma</u> OWNER NAME	<u>James Jongsma Dairy No. 2</u> FACILITY NAME
<u>CAG018001</u> NPDES NUMBER	Ex. 6 Personal Privacy (PP)	
<u>R8-2007-0001</u> RWQCB ORDER NO.	<u>Pixley, CA 93256</u> OWNER ADDRESS	<u>Ontario, CA 91761</u> FACILITY ADDRESS
<u>04/12/2013</u> SCHEDULED INSPECTION DATE	<u>James Jongsma</u> OWNER CITY AND STATE	<u>Jesse Jongsma</u> FACILITY CITY AND STATE
<u>04/11/2013</u> ACTUAL INSPECTION DATE	<u>James Jongsma</u> OWNER CONTACT	<u>Jesse Jongsma</u> FACILITY CONTACT
<u>Santa Ana River</u> RECEIVING WATER	Ex. 6 Personal Privacy (PP)	
	<u>Ex. 6 Personal Privacy (PP)</u> OWNER PHONE NO.	<u>Ex. 6 Personal Privacy (PP)</u> FACILITY PHONE NO.
	<u>Ex. 6 Personal Privacy (PP)</u> FACILITY LATITUDE	<u>Ex. 6 Personal Privacy (PP)</u> FACILITY LONGITUDE

REPORT PREPARED BY: Anthony D'Angelo (PG Environmental, LLC) ON 04/29/2013

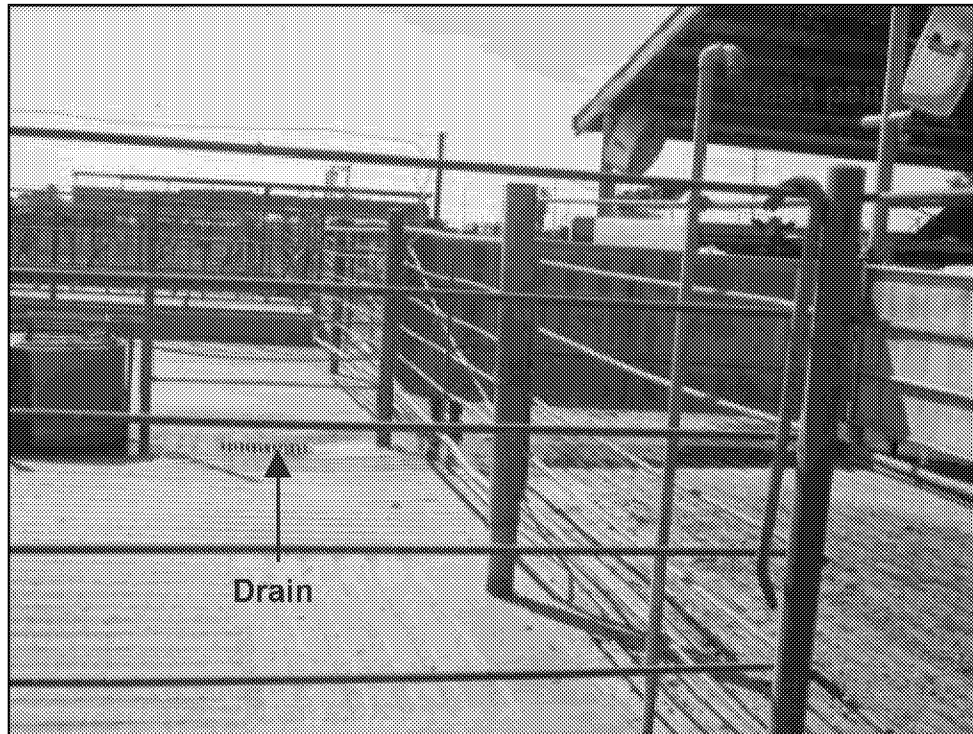
Photograph 2. View facing west of the wash pen drain located on the south side of the milking barn. The drain conveys process wastewater west to a conveyance ditch that can be diverted into the Facility lagoons or evaporation ponds.

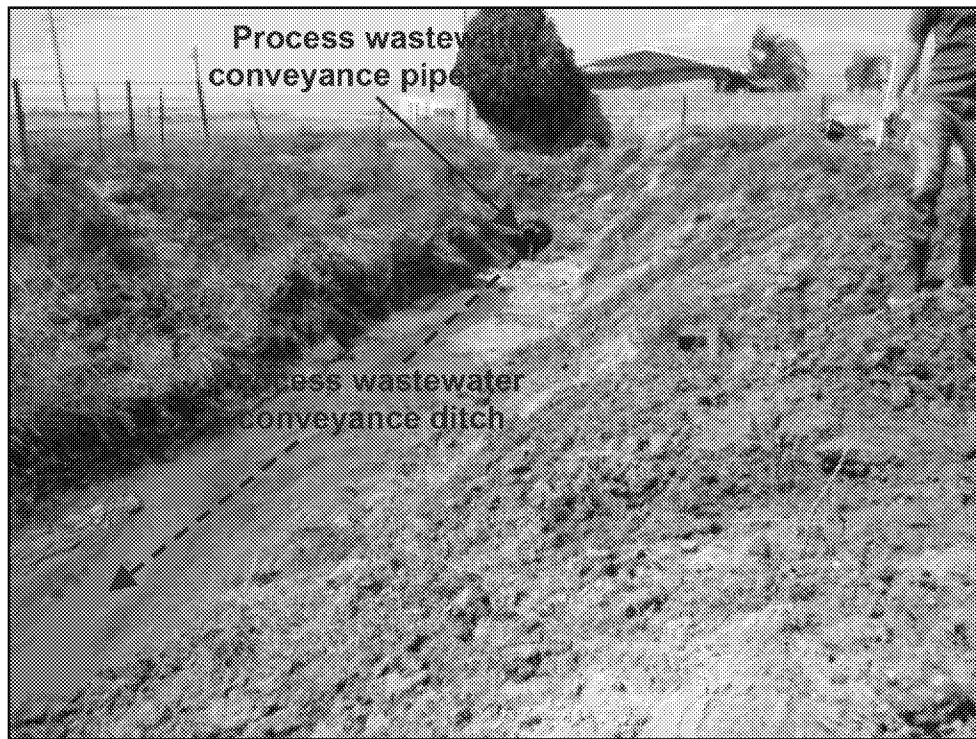
Photograph 3. View facing north of the process wastewater conveyance pipe outlet and conveyance ditch in the northwest corner of the Facility.

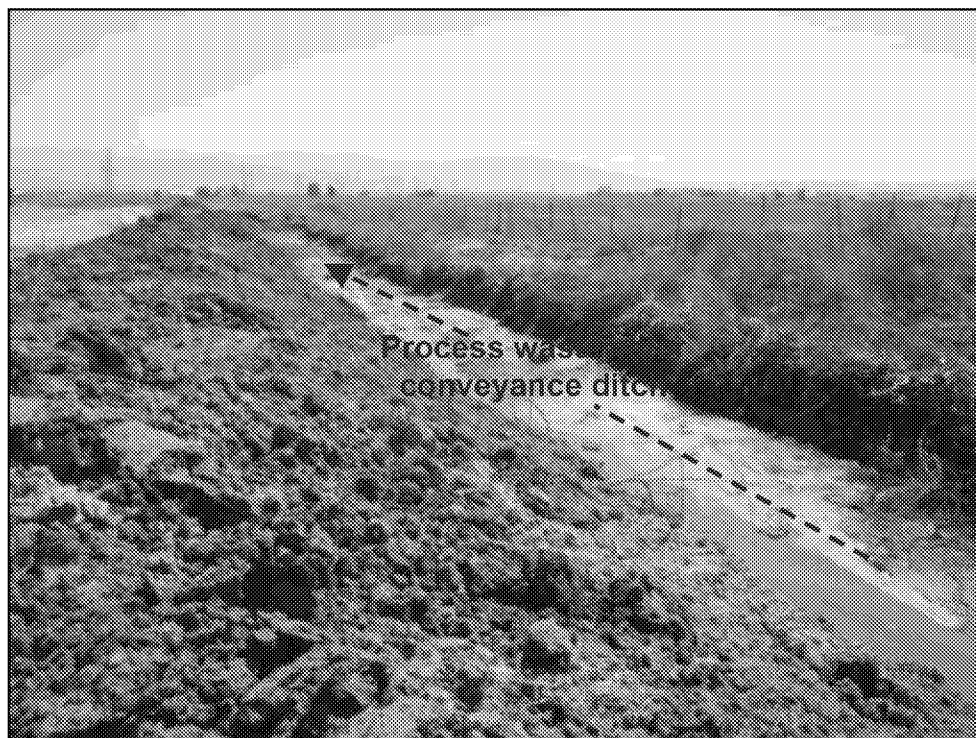
Photograph 4. View facing south of the process wastewater conveyance ditch along the west perimeter of the Facility. Note the ditch was actively conveying process wastewater into evaporation pond No. 3.

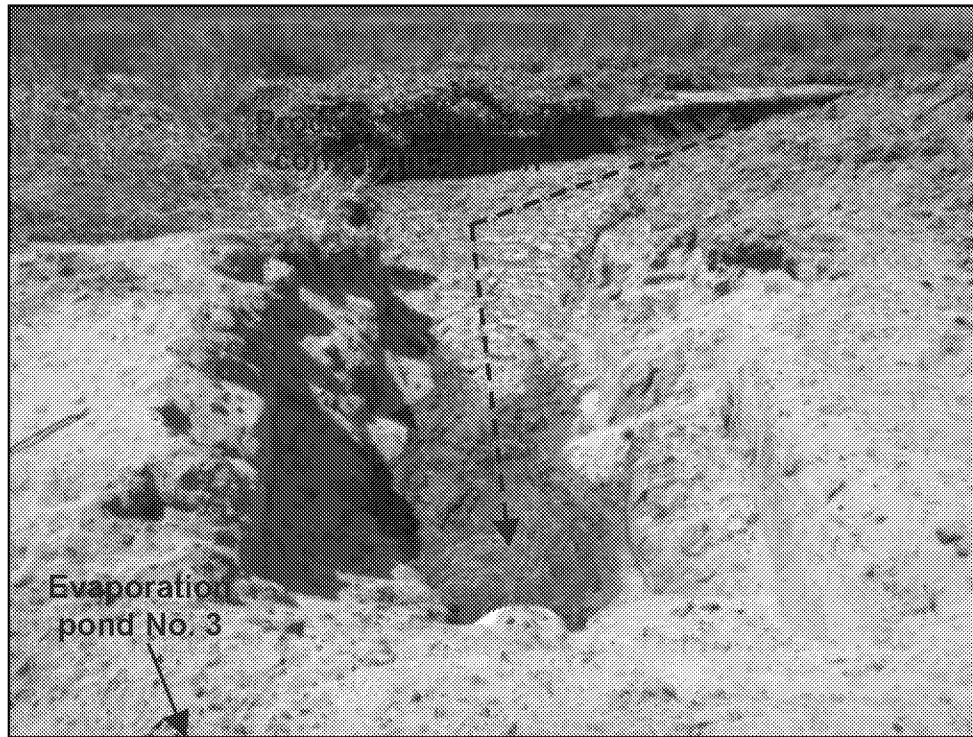
Photograph 5. View facing west of the process wastewater conveyance ditch diversion into the west side of evaporation pond No. 3.

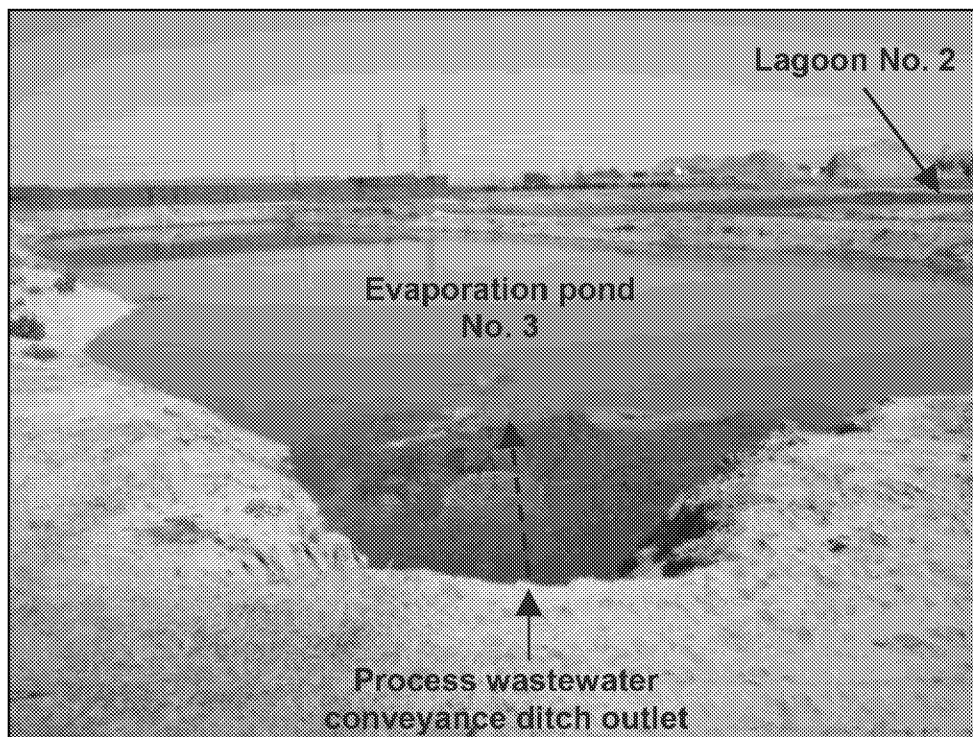
Photograph 6. View facing southeast of process wastewater actively flowing into evaporation pond No. 3, via the process wastewater conveyance ditch shown in Photographs 3, 4, and 5.

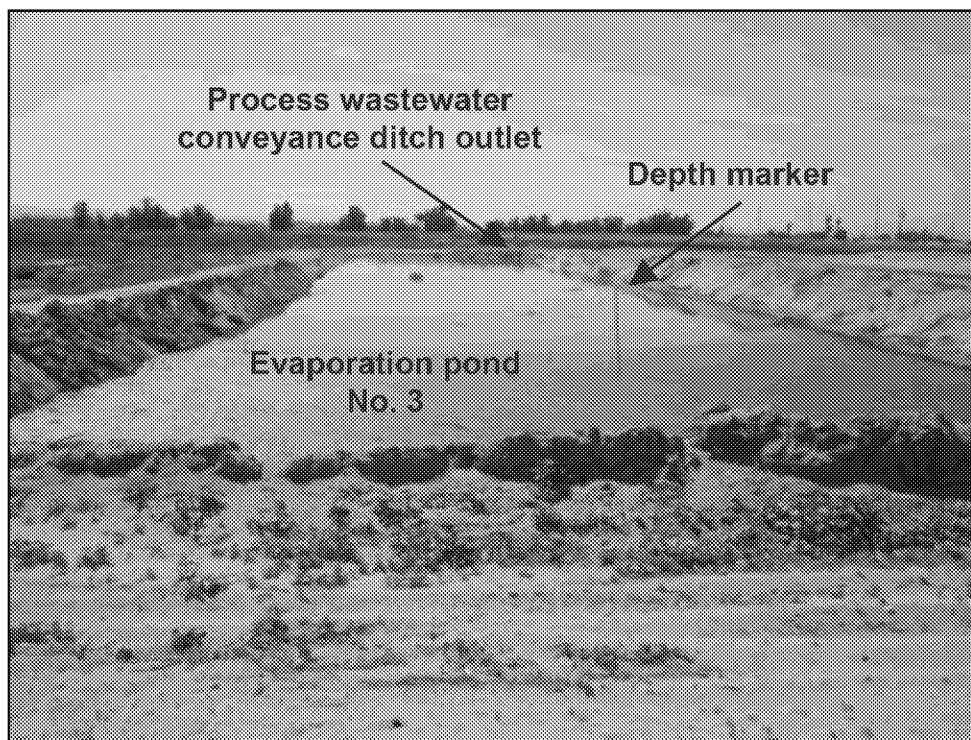
Photograph 7. View facing west of evaporation pond No. 3. Note this pond was receiving all process wastewater from the milking barn and wash pen at the time of the inspection.

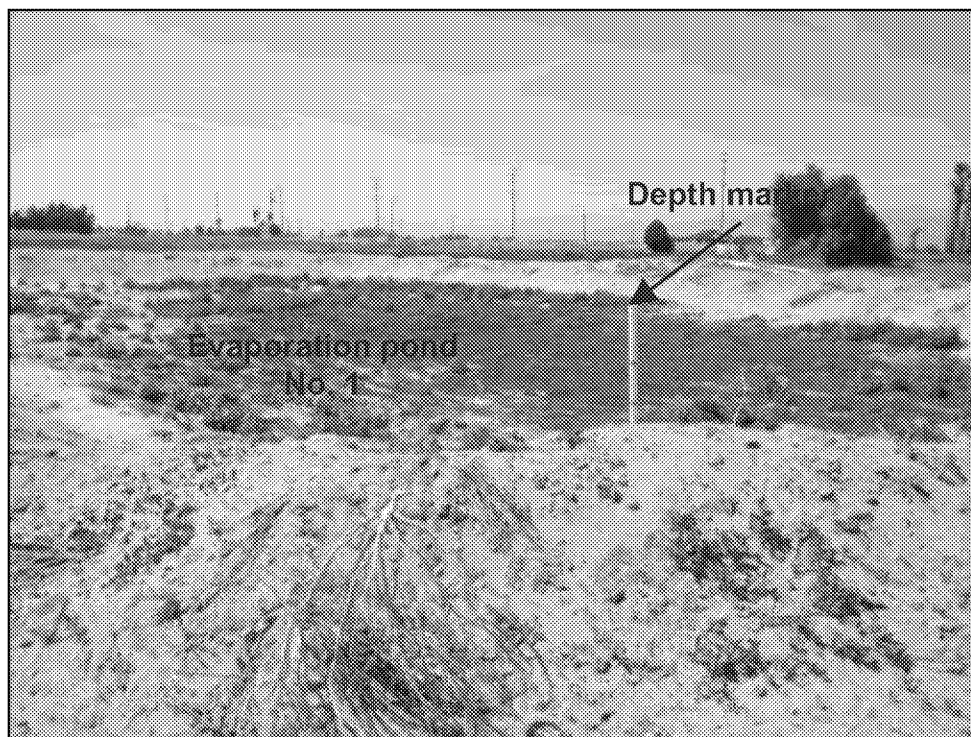
Photograph 8. View facing northwest of evaporation pond No. 1 located in the northwest portion of the Facility.

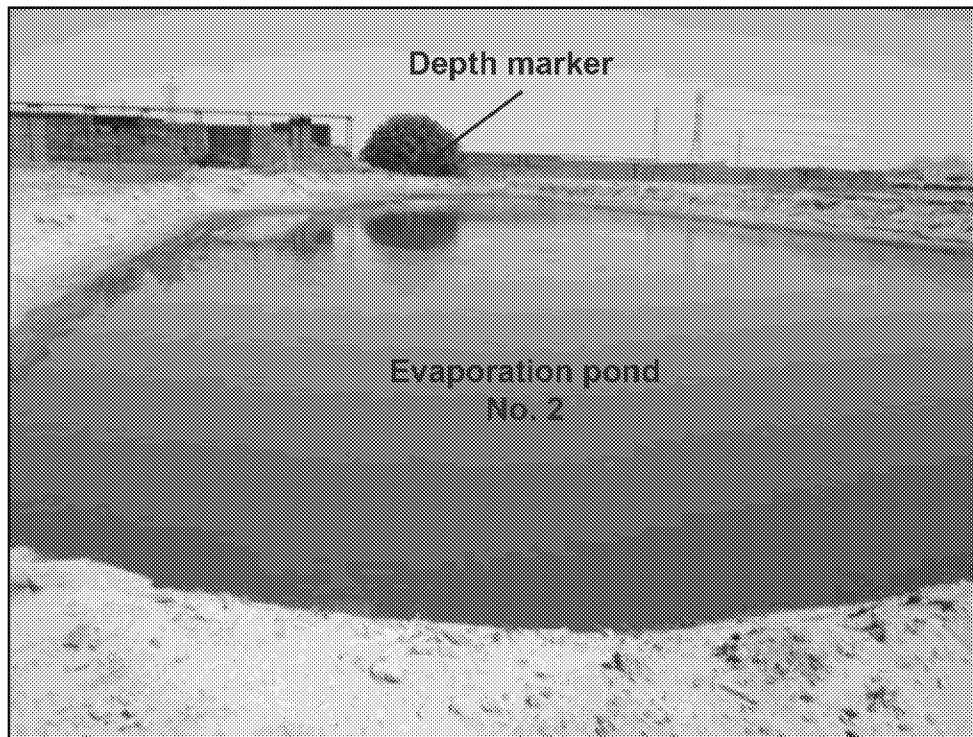
Photograph 9. View facing east of evaporation pond No. 2. Evaporation pond Nos. 2 and 3 contained process wastewater accumulation at the time of the inspection.

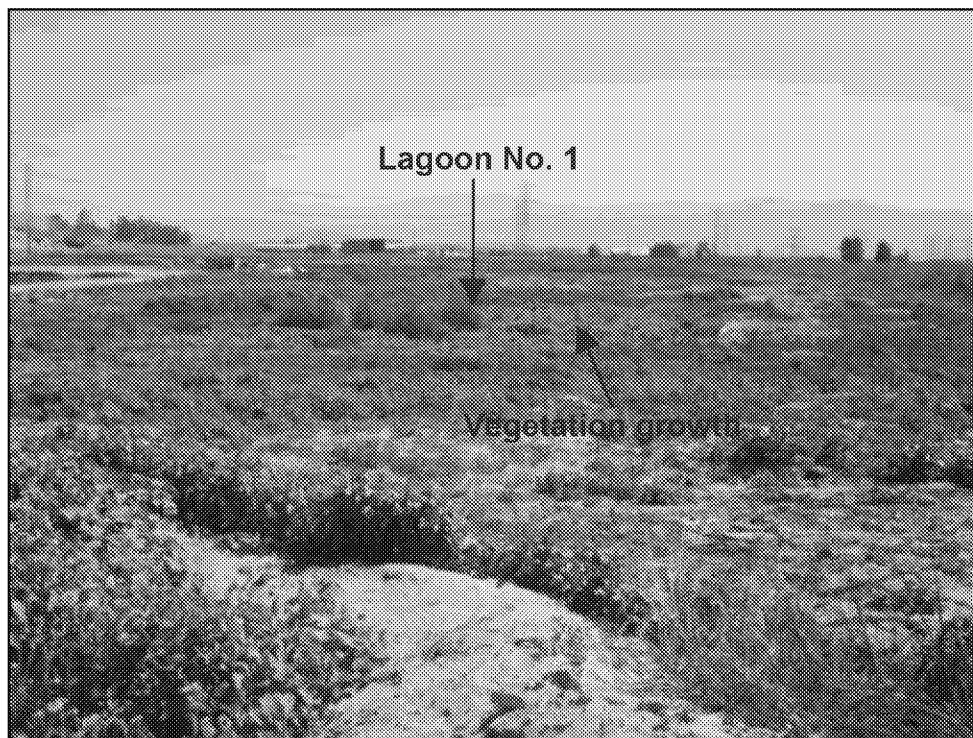
3. Accumulated manure solids and vegetation growth was observed in lagoon Nos. 1 and 2 located in the southwest portion of the Facility (refer to Photos 10 through 14). The Discharger must design and maintain all containment structures per the EWMP as required by Provision VII.C.3.a of the Permit.

Photograph 10. View facing south of lagoon No. 1. Note the lagoon was observed containing accumulated solids and vegetation growth. Mr. Brian Jongsma stated the lagoon contained approximately three (3) feet of accumulated solids.

2. The inspector observed, during the inspection, that vegetation growth potentially affecting the containment structure capacity was observed in lagoon No. 1 located in the southwestern portion of the Facility (refer to Photos 10 and 11). Mr. Brian Jongsma stated the Facility containment structures were in poor condition when the Discharger took operational control less than one (1) year ago, and that lagoon Nos. 1 and 2 were currently being dried out so they could be maintained. It appeared to the inspector that the vegetative growth in lagoon No. 1 was most likely growing out of the accumulated lagoon solids (refer to Photo 11). As a result, the overall capacity of the containment structures at the Facility may be diminished. Provision VII.C.3.a of the Permit states that "the discharger shall design, construct and maintain containment structures to retain all wastewater within the facility, including all process wastewater and all precipitation on, and drainage through, manured areas resulting from rainfall up to and including a 25-year, 24-hour rainfall event." The Discharger must design and maintain all containment structures per the EWMP as required by Provisions VII.C.3.a of the Permit.

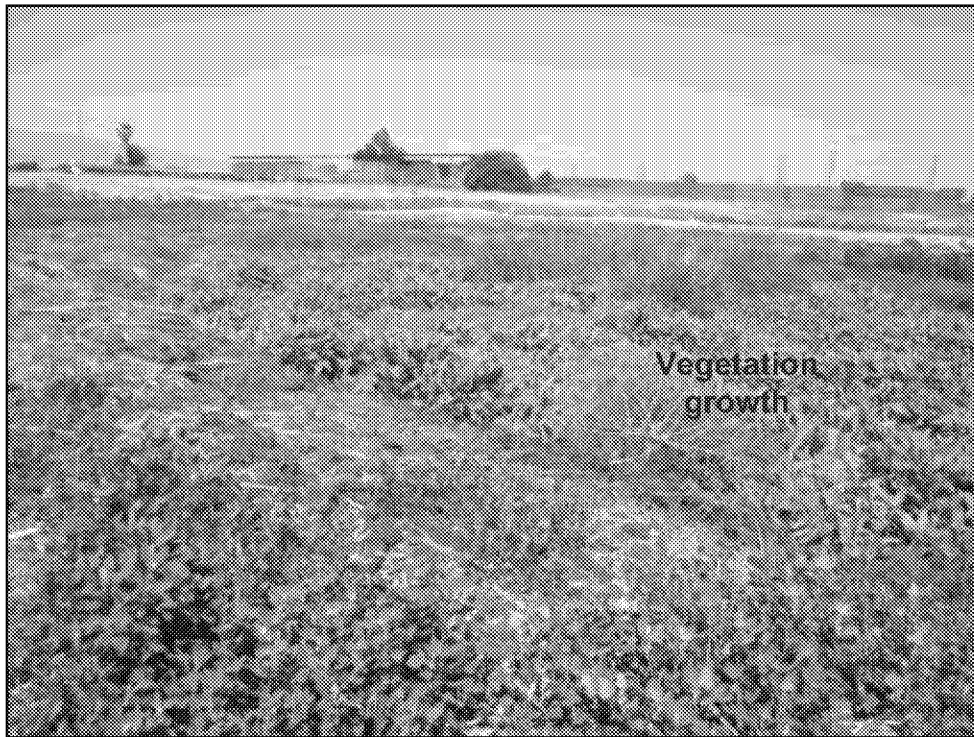
Photograph 11. View facing northeast of the vegetation growth on the north side of lagoon No. 1.

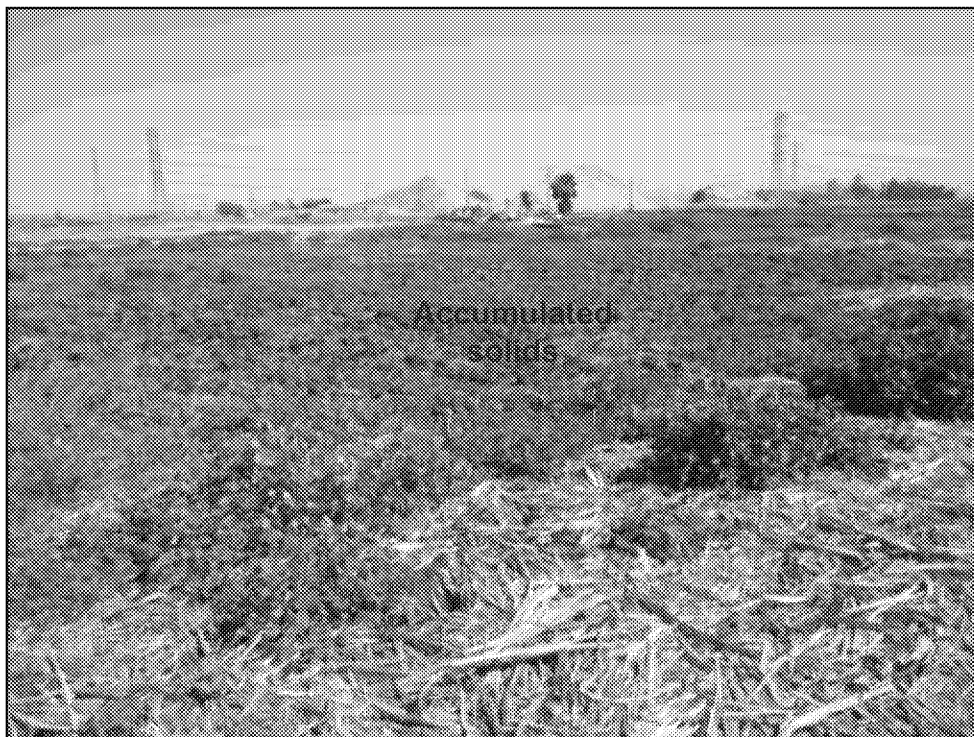
1. The inspector observed, during the inspection, accumulated solids in lagoon Nos. 1 and 2 located in the southwestern portion of the Facility (refer to Photos 12, 13, and 14). Mr. Brian Jongsma stated the Facility containment structures were in poor condition when the Discharger took operational control less than one (1) year ago, and that lagoon Nos. 1 and 2 were currently being dried out so they could be cleaned of accumulated solids. In addition, he stated that lagoon No.1 contained approximately three (3) feet of accumulated solids. It should be noted that item No. 5 of the 'Recommendations' section of the EWMP states that "lagoon #1 must be pumped down and maintained at a maximum depth of 5 feet to accommodate the runoff from the 25-year storm." As a result, the overall capacity of the containment structures at the Facility may be diminished. Provision VII.C.3.a of the Permit states that "the discharger shall design, construct and maintain containment structures to retain all wastewater within the facility, including all process wastewater and all precipitation on, and drainage

Photograph 12. View facing south of accumulated solids in lagoon No. 1.

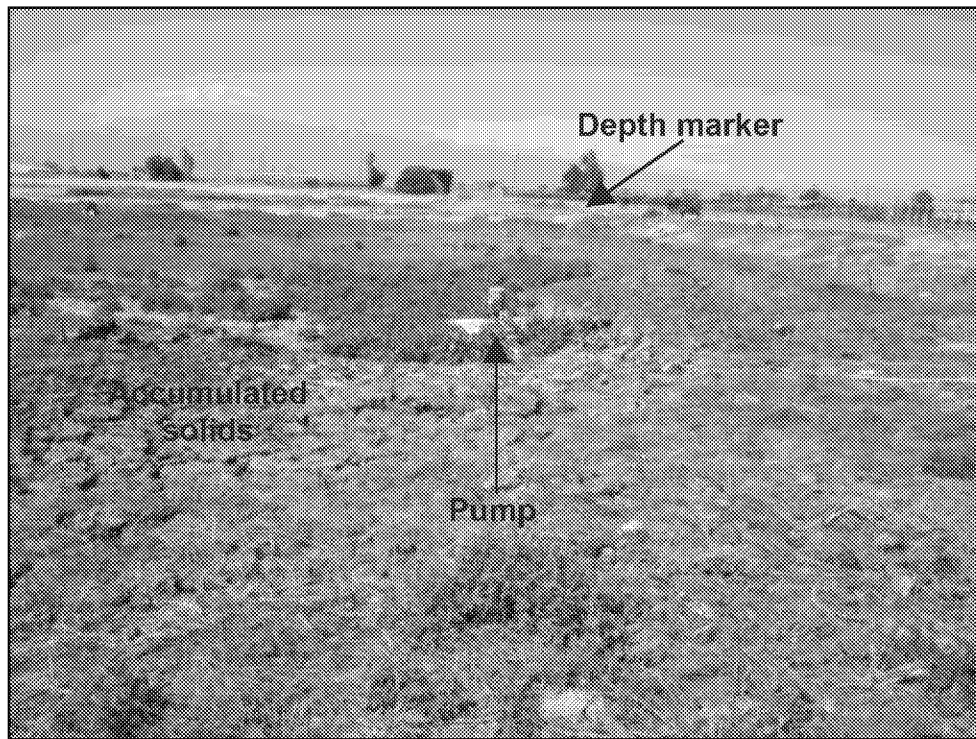
Photograph 13. View facing north of accumulated solids and a pump located on the southern side of lagoon No. 1.

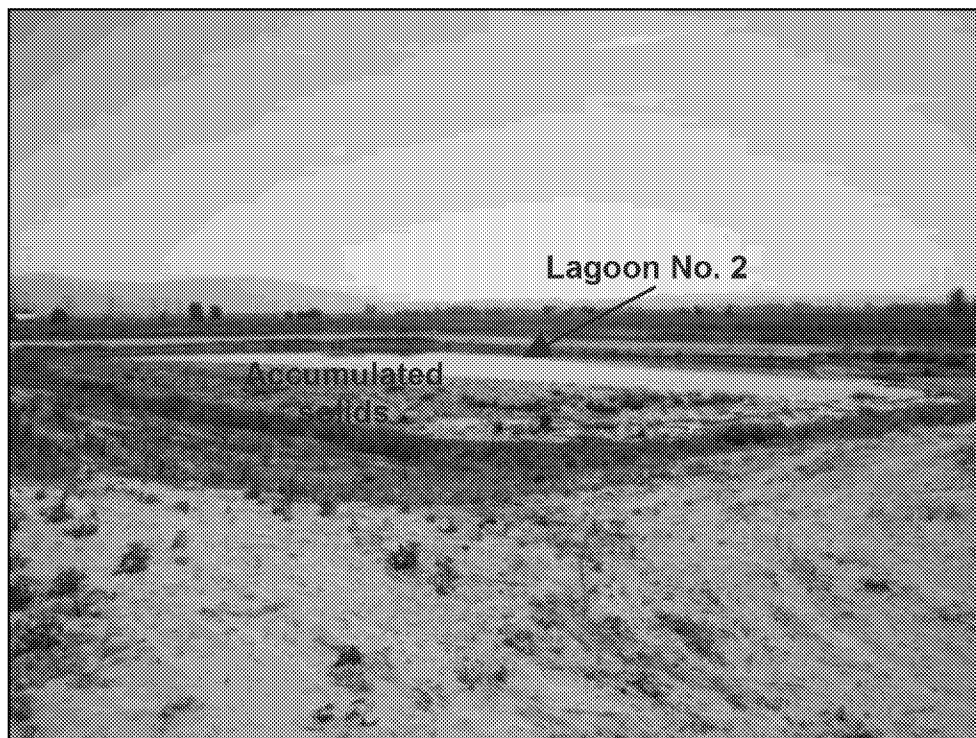
1. A depth marker was not implemented in lagoon No. 2 located in the southwest portion of the Facility, as required by Permit Attachment B - Monitoring and Reporting Program, Section I.B.1 (refer to Photo 14).

1. The inspector observed, during the inspection, that a depth marker was not implemented in lagoon No. 2 located in the southwestern portion of the Facility as required by the Permit (refer to Photos 14). Mr. Brian Jongsma stated that the operator had installed depth markers in all lagoons and evaporation ponds when the Discharger first took operational control of the Facility less than one (1) year ago. Permit Attachment B - Monitoring and Reporting Program, Section I.B.1 states that "a marker shall be placed within each pond or impoundment to indicate the minimum capacity necessary to contain the runoff and direct precipitation of the 25-year, 24-hour rainfall event."

Photograph 14. View facing southwest of lagoon No. 2. Note the lagoon contained accumulated solids. Also note the lagoon did not contain a depth marker.

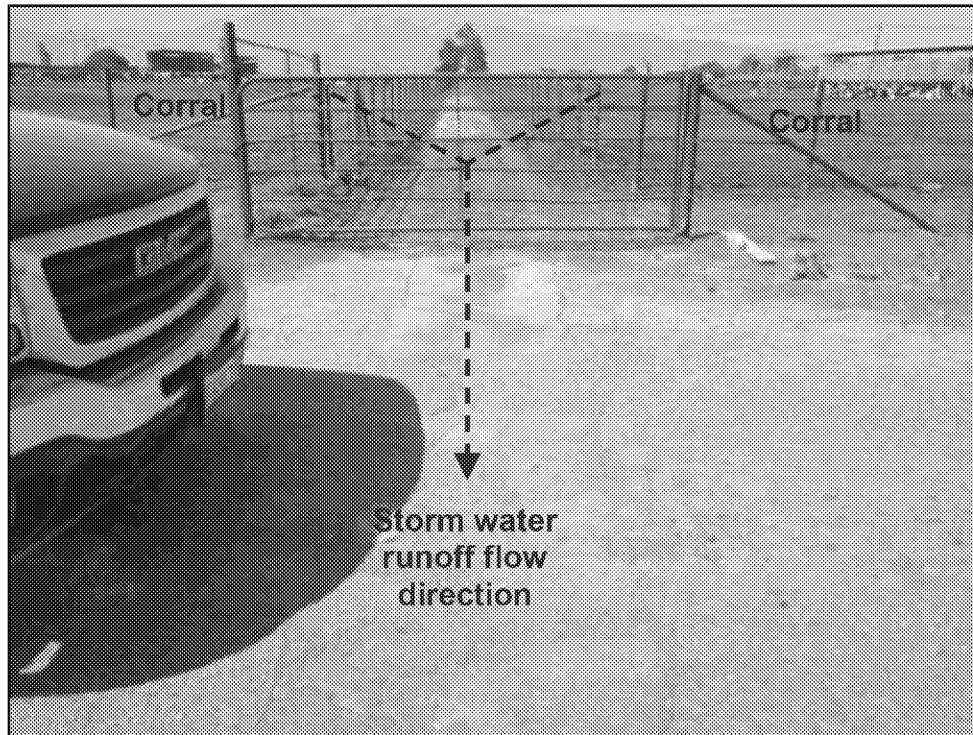
Photograph 15. View facing north of the corral cow lane. All storm water runoff from the corrals flows into the cow lane located in the center of the corrals. From the cow lane, storm water continues south to the southern Facility perimeter, and then west into lagoon No. 1.

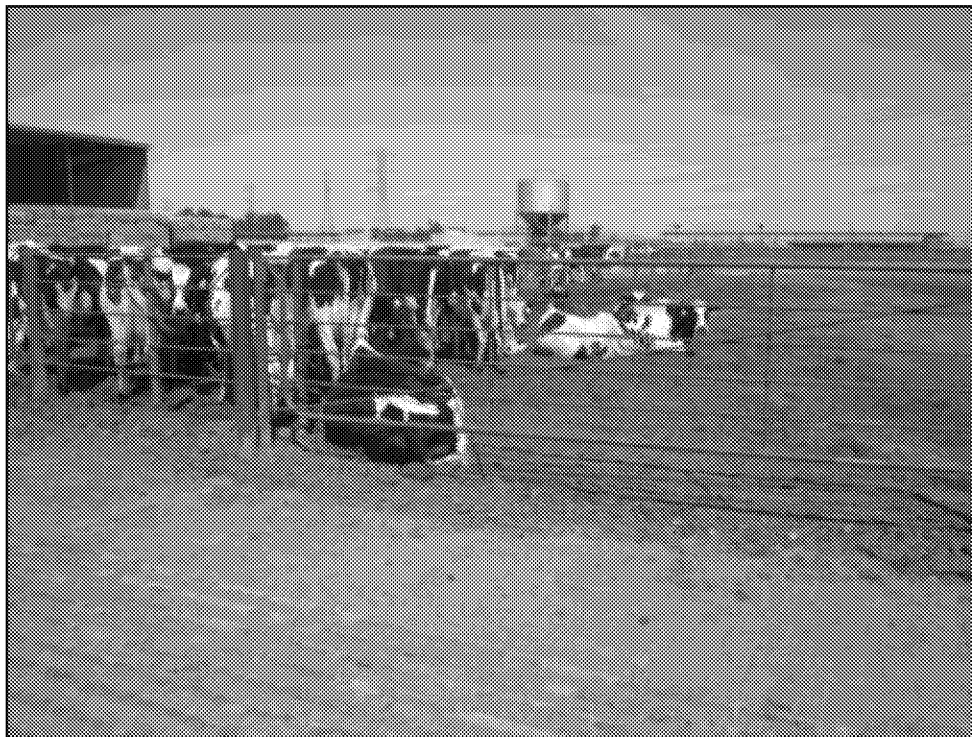
Mr. Brian Jongsma stated that the corrals are typically cleaned three (3) to four (4) times per year and were last cleaned one week prior to the inspection (refer to Photo 16). All manure is hauled offsite by Maryville Trucking; however, manure tracking manifests were unavailable for review due to the absence of the primary operator. A manure stockpile was observed in the eastern portion of the Facility, adjacent to Haven Avenue (refer to Photo 17). In addition, Mr. Brian Jongsma stated that all mortalities are removed from the Facility immediately by Stiles Animal Removal, Inc.

Photograph 16. View facing northeast of the dry cow corral in the southeast corner of the Facility. Corrals appeared to be well maintained.

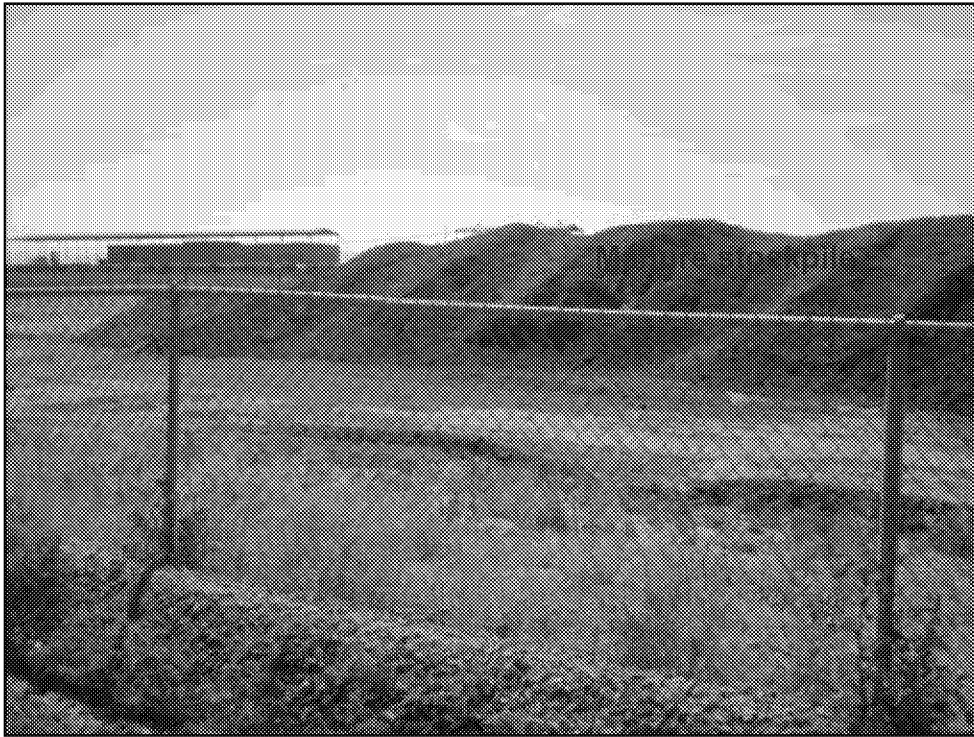
Photograph 17. View facing southwest of the manure stockpile located on the east side of the Facility, adjacent to Haven Avenue.
